# Manhole Inspection Summary

Manhole # S25I\_\_023MH

Insp Date: **4/1/09 7:13 AM**

**Location** Address: **Lemmon St**

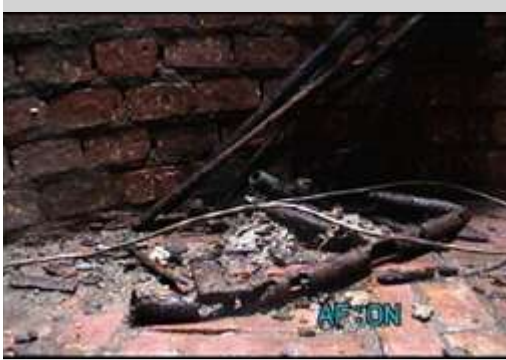
Miscellaneous

Condition: ☒ Sound ☐ Cracked ☐ Root Intrusion ☐ Deteriorated ☐ Leaks ☐ Debris

debris on bench

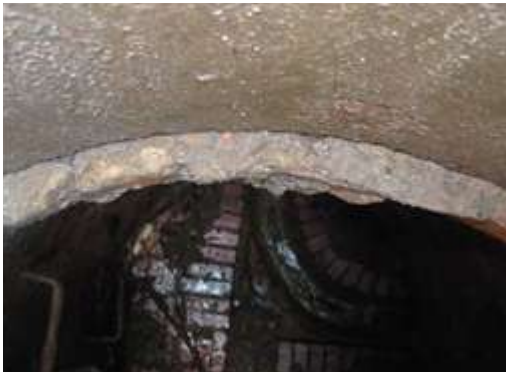
Defect 6

**Frame** Offset: **1.5** (in.) Condition: ☐ Sound ☐ Cracked ☒ **Leaks**

1.5" offset

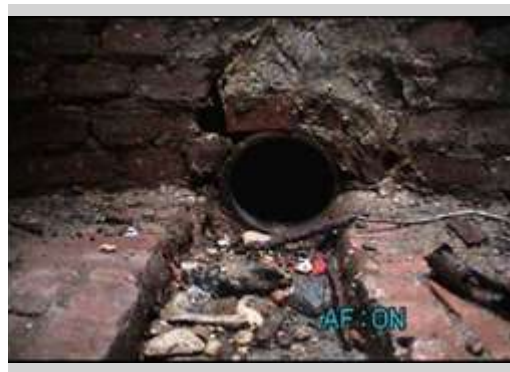
Defect 1

Condition: ☐ Sound ☐ Cracked ☐ Root Intrusion ☐ Deteriorated ☐ Leaks ☒ **Debris**

debris in channel from 6:00 pipe connection

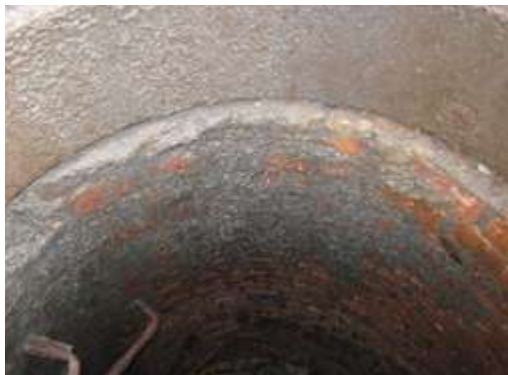
Defect 3

Condition: ☐ Sound ☒ **Cracked** ☐ Root Intrusion ☐ Loose Brick ☐ Deteriorated

Infiltration: ☐ None ☐ Joint ☐ Cracks ☒ **Mortar** ☐ Roots ☐ Wall

Infiltration: ☐ None ☐ Joint ☐ Cracks ☐ Mortar ☐ Roots ☒ **Wall**

frame leaks; gap between frame and chimney, chimney and corbel infiltration

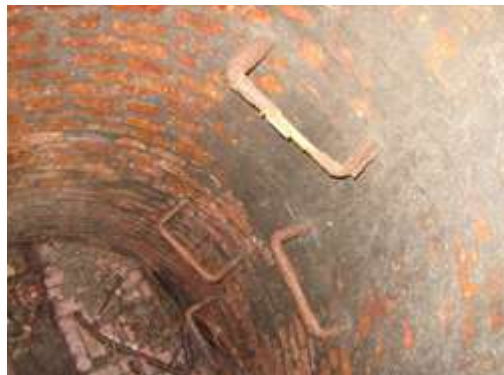
Defect 2

**Steps** Count: **4** Missing: **0** ☒ **Corroded**

corroded rungs
